Report on Repairs

Aransas Princess

720 Beach Access Road 1-A
Aransas, Texas

Prepared by Roy R. Pachecano, AIA

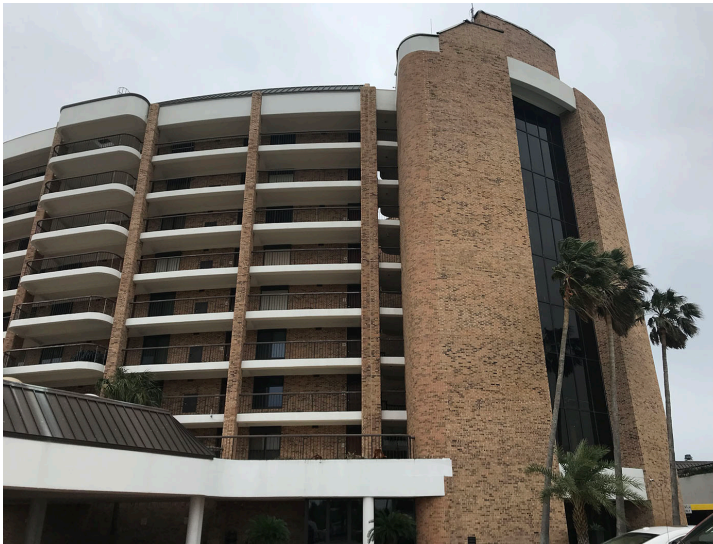
1. West Façade—Main automobile drop-off.

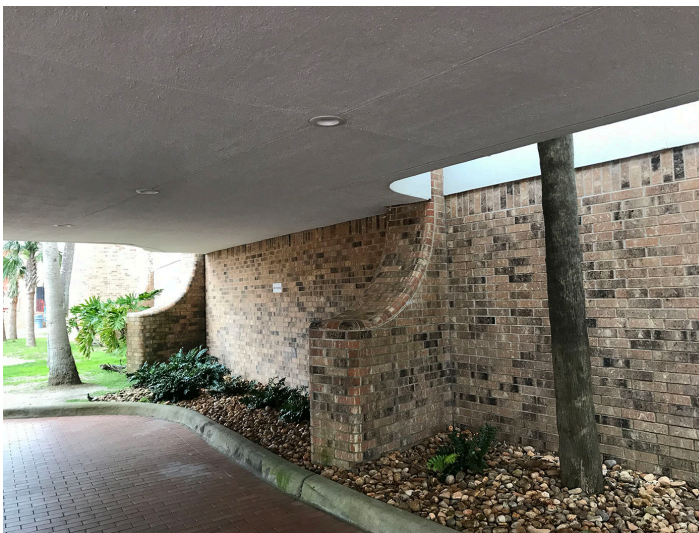
2. Main automobile drop-off / Porte coche.

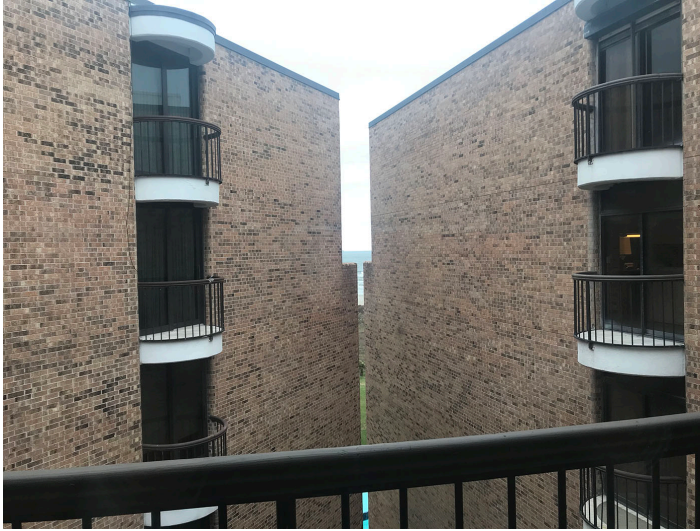
3. Upper Level Corridor facing East Façade—at interior court.

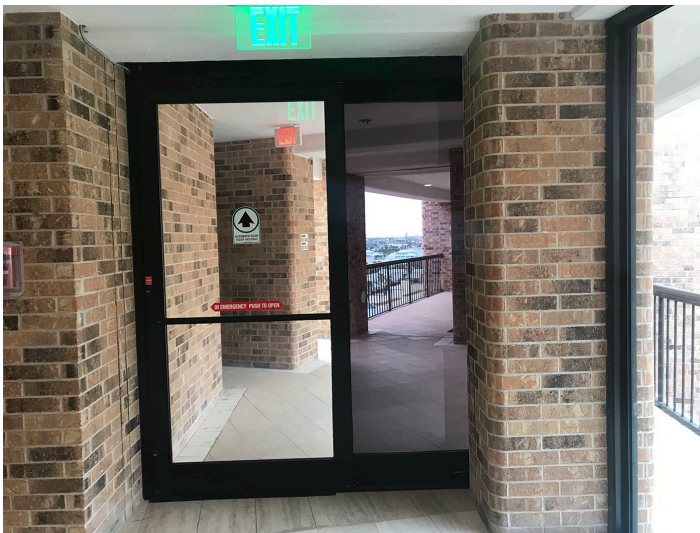
4. Upper level lobby—typical of lobbies for condominium access.

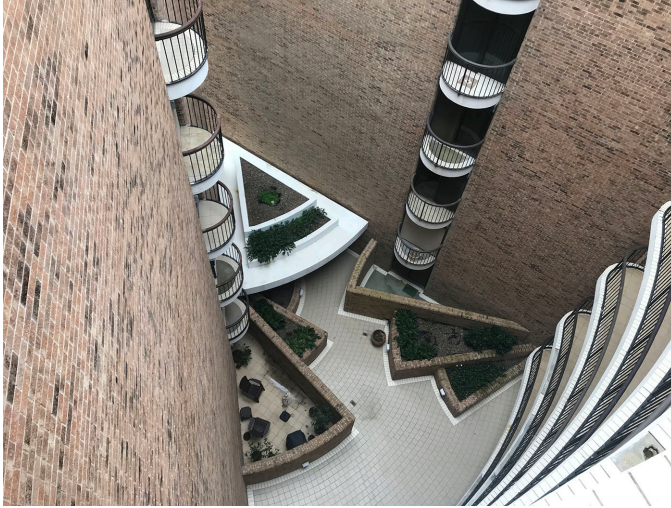
5. View from upper level looking down to interior court.

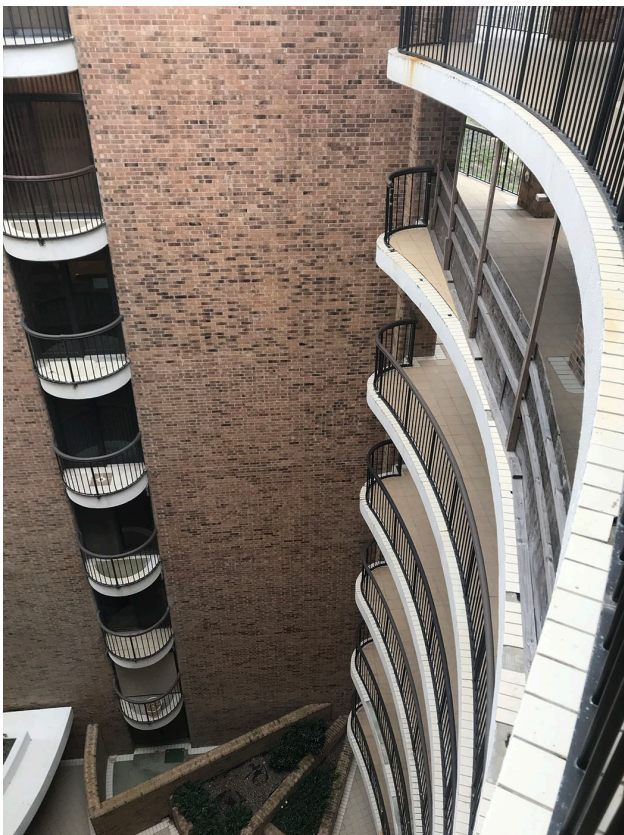
6. Oblique view from upper level looking down to interior court.

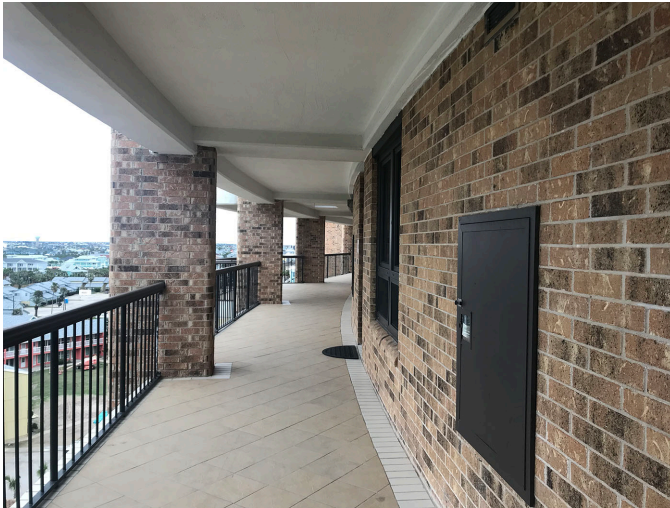
7. Exterior corridor at West façade—typical at all condominium access levels.

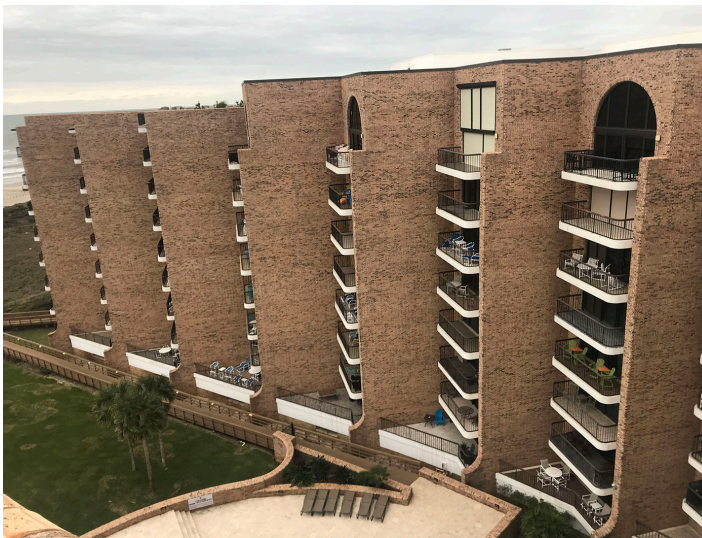
8. Oblique view from of south portion of Subject Property facing the Gulf of Mexico.

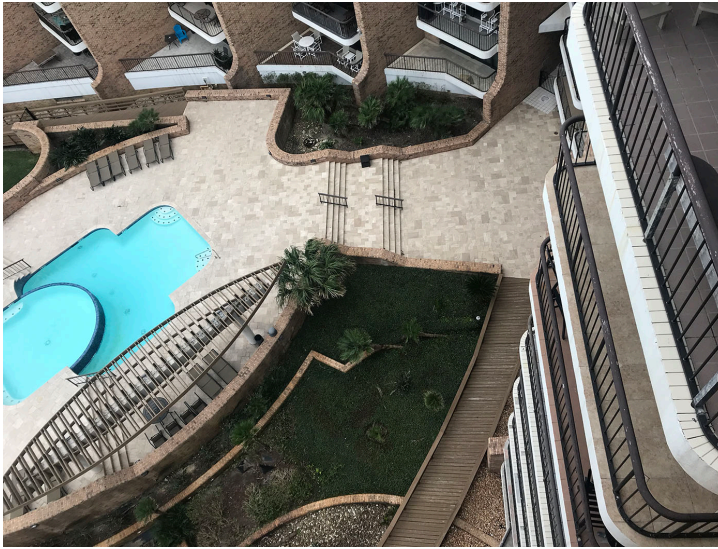
9. Oblique view from upper level looking down to exterior court facing Gulf of Mexico.

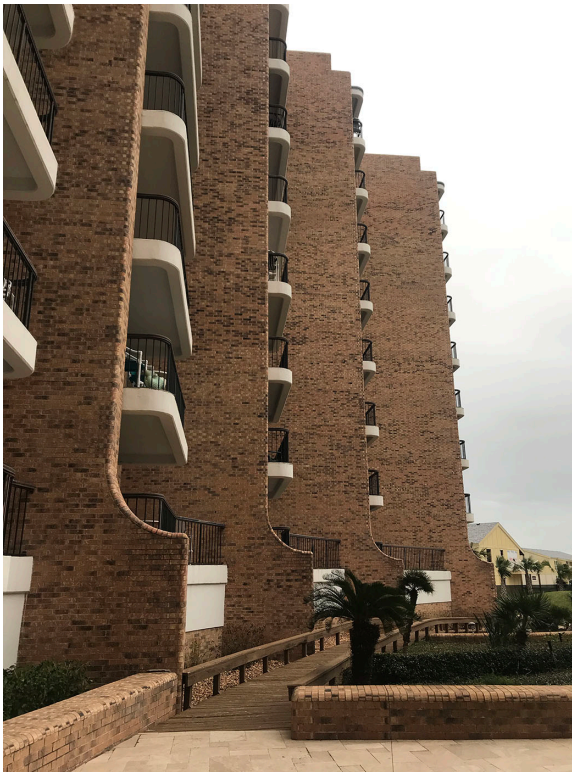
10. View from exterior court looking up at north portion of Subject Property.
